Dam ID: KA-0103 H1 00103
Aepo Reservoir

Inspection No: _____
Date: 03/20/2006

STATE OF HAWAII - DLNR
VISUAL DAM SAFETY INSPECTION SHEET

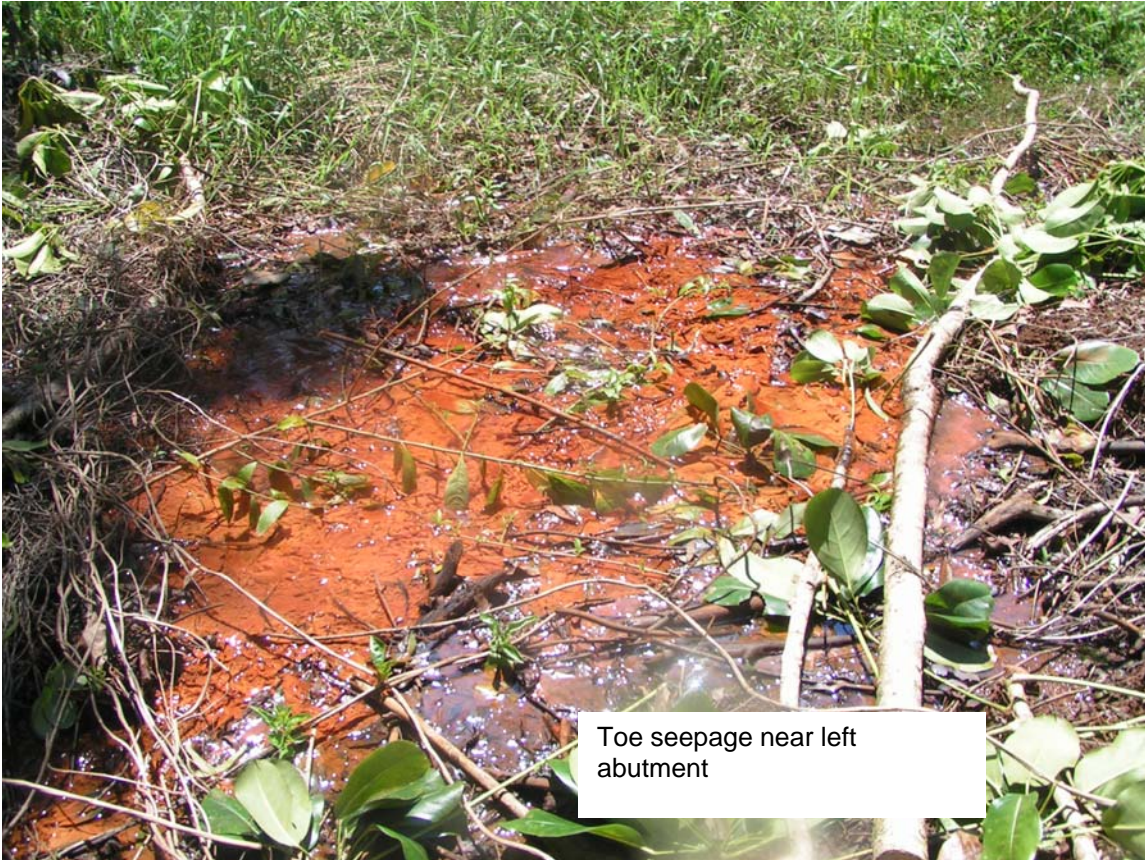
Seepage: Seep Spot Number 1

☐ Green Vegetation ☒ Wet or Muddy Ground ☐ Ponding Water ☐ Not Visible ☐ None Observed

X Flowing, Description: Very low flow

Description: Near toe at left abutment.

1. Seepage at toe near left abutment

Toe seepage near left abutment

Seepage should be monitored to be sure that piping (i.e. internal erosion) does not develop.

- If seepage is observed, a V-notch weir, Parshall flume, etc., should be installed along or near the downstream toe of the dam to collect & monitor/measure the rate or volume of seepage with respect to changes (i.e. increase & decrease) in reservoir (pool) elevation.

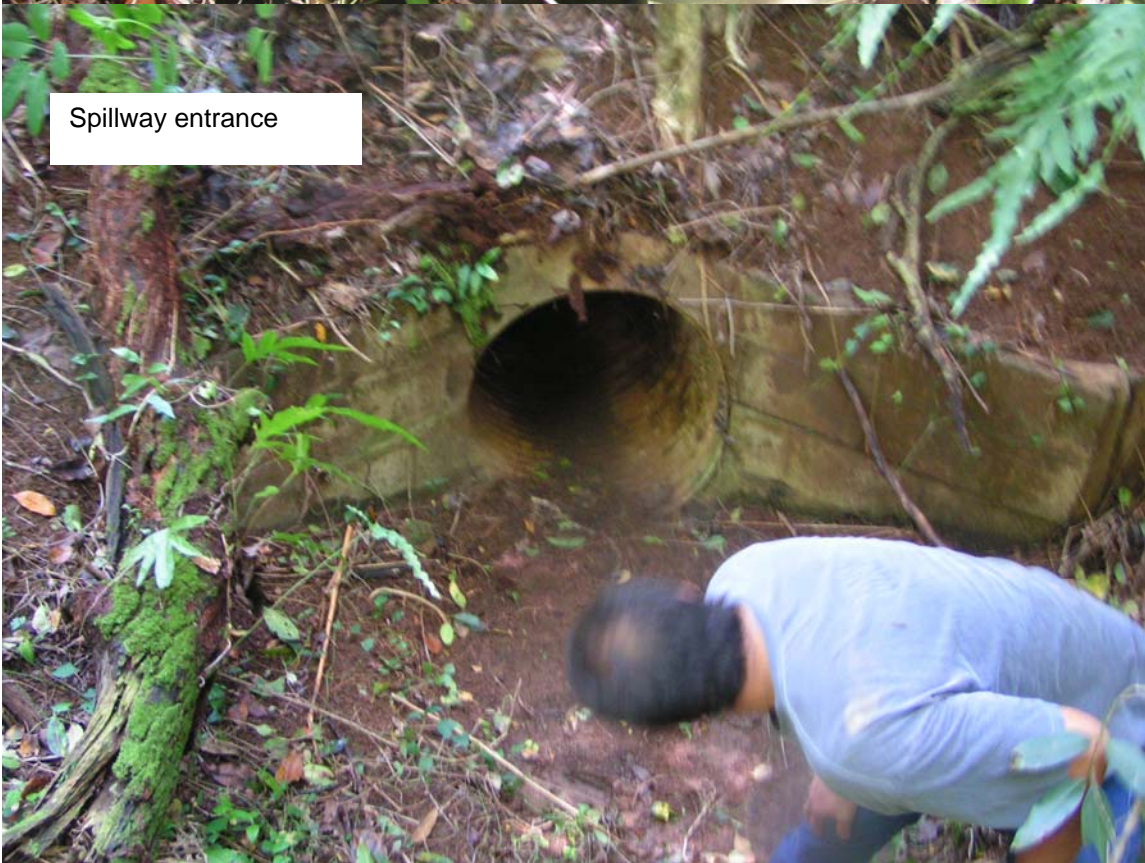
(spillway was ill defined and flowed through a 30" culvert)

2. Spillway ill defined.

Spillway entrance

- Monitor spillway during future high pools and evaluate for possible remediation.

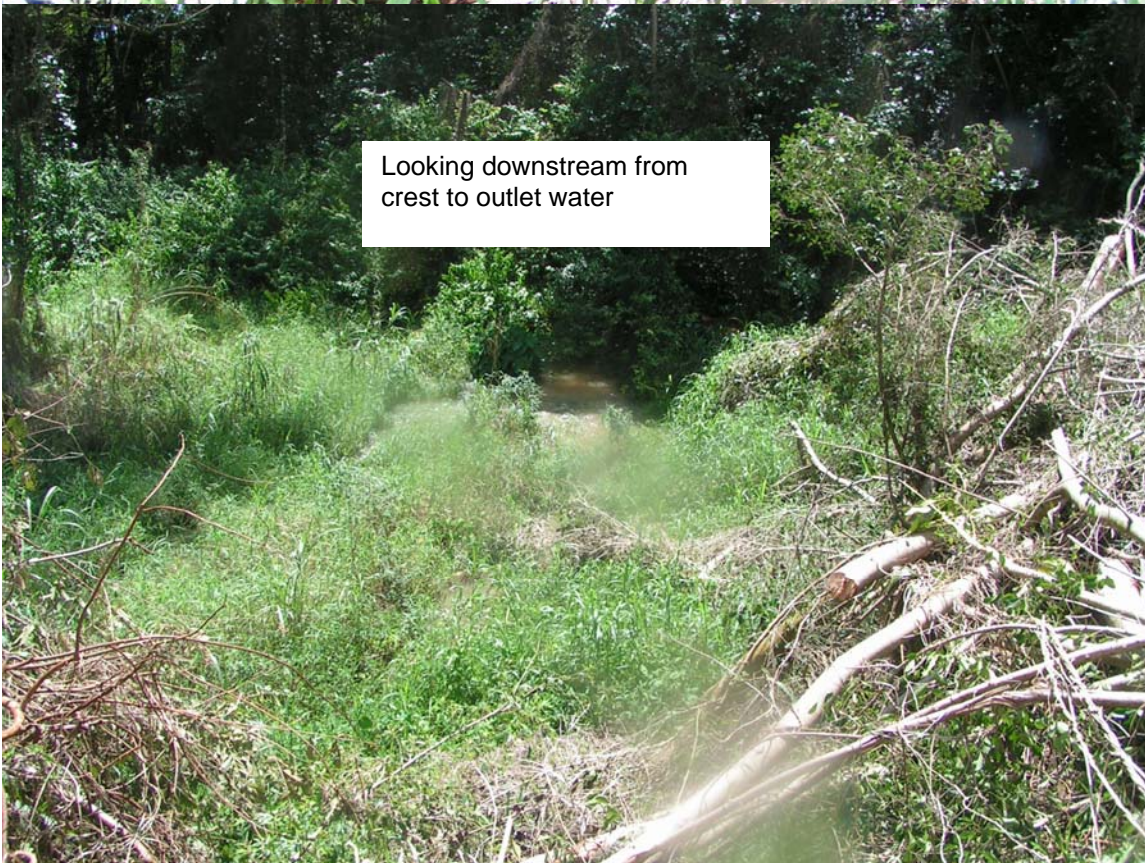
Description: Covered with cut down trees

Description: and downed trees

3. Vegetation on ds/slope and toe need access to toe.

4. Very steep slope.

Downstream slope

- The slopes should be clear and visible for inspection. The existing trees have been allowed to grow so large in some cases that there is concern that seepage and piping (i.e. internal erosion) along root systems may develop. There is additional concern that cutting and killing the trees will lead to rotten roots and greater potential for such seepage and piping. A more in depth evaluation of the condition should be performed to determine how best to remediate the condition.

-. A path or roadway along the groins, the toe and to the outlet discharge point should be cleared and maintained to facilitate periodic inspection, maintenance, monitoring of seepage conditions, and remediation, if required.

- The stability of the slopes should be further evaluated. If flattening of the slopes is required incorporation of measures to resolve clearing, and potential seepage issues on the downstream slopes may be possible.
